Historic Sites Unit Department of Tourism & Culture 204 Lambert St Whitehorse, Yukon

ERA Architects Inc. #600-625 Church Street Toronto, Ontario M4Y 2G1 416-963-4497 Project # 24-052-01

4 INVENTORY AND CONDITION ASSESSMENT (JUNE 2024)

On June 12-13, 2024, ERA conducted a site visit to document and assess the damage and change that has occurred on Site as a result of the ice jam and flood, as well as during the 13 months following the event.

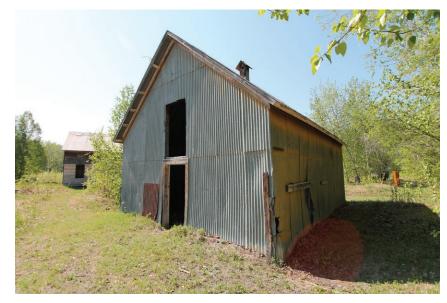
The Fish House was destroyed and its building components lost in the Site's May 2023 ice jam and flood. Its foundation pads and former "floor" remain visible, with new growth having formed around them.

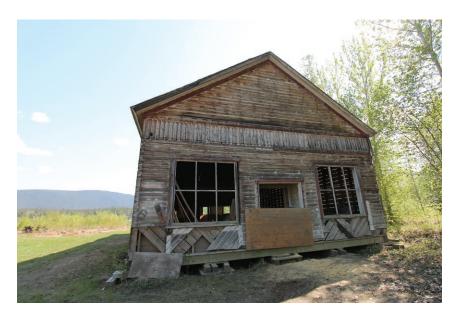
The Alaska Commercial Company Warehouse was destroyed and its building components lost in the Site's May 2023 ice jam and flood. Its foundation pads and/or other markers of its former location appear to remain in the ground, and have since been covered by new growth.

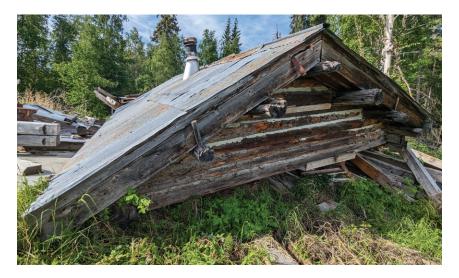
In the May 2023 ice jam and flood, the building was relocated, collapsed and resting on the Metalworking Shop, and substantially dismantled. The building was found to be in **defective** condition, with the majority of the

- The ground floor walls were missing. Debris in and around the building appeared to be displaced building elements; additional building materials appeared to be scattered in the adjacent area;
- The floor structure was sitting adjacent to the building, deformed and in defective condition;
- The roof systems appeared in fair condition, with select areas of poor condition. The metal roofing appears to have sustained minor damage from the collision and separation from the main building, however appeared mostly intact;
- The rear addition had been separated from the main building, with its roof system appearing intact, with only minor damage;
- The building's foundation pads appeared to remain in the ground at the building's original location;
- Some windows were observed in the building debris; however, not all were accounted for.

AFTER: Roadhouse from side, showing rear of main building and separation and breakup of former addition (ERA, 2024)

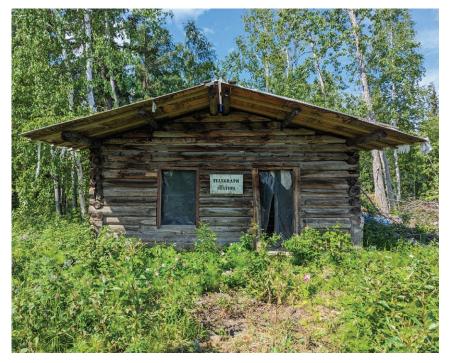
The Telegraph Station experienced minor relocation during the May 2023 ice jam and flood, but remains substantially intact as of June 2024. The building was found to be in **fair** condition, with select areas of **poor** condition.

- The timber walls appeared to be in fair condition with minor displacement of the logs at the front elevation;
- The floor structure appeared to be intact, and coated with silt and debris from the flood;

- The roof system appeared to be in defective condition; however, the roof
 was in the process of being restored prior to the flood. The second layer
 of metal roof with ridge cap was noted as missing in the assessment, but
 had previously been removed for repairs. The lower plywood structure
 remained intact, and a tarp was observed covering the roof;
- The windows and doors appeared to be missing, although window and door openings were found to be in fair condition. Plastic sheeting has been installed to temporarily cover the doors and windows.

AFTER: Telegraph Station (ERA, 2024)

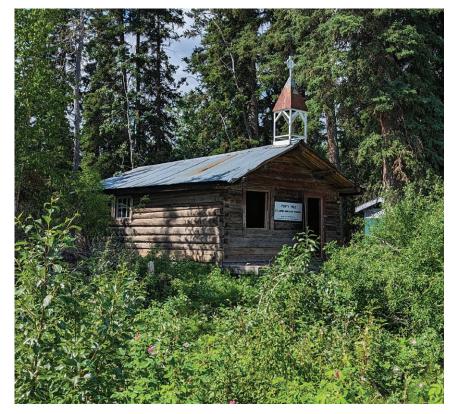
St. James Anglican Church experienced a minor relocation and sustained minor damage in the May 2023 ice jam and flood, but remains substantially intact. The building was found to be in **fair** condition.

• The timber walls appeared to be fair condition, with no flood damage observed;

- The floor appeared to be in fair condition, with only flood debris and silt on the floor;
- The roof appeared intact, with only minor damage to the corrugated metal;
- The window on the front elevation appeared to be missing; however, YG staff verified that it had been pushed in by flood water, is undamaged, and is currently in storage. The other windows remained *in situ*;
- The front porch is in defective condition, with the majority of the framing members dislodged and broken;
- The corrugated metal skirting appears to be in fair condition.

AFTER: Anglican Church (ERA, 2024)

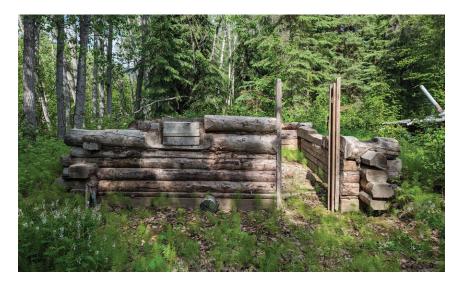
AFTER: Willie DeWolfe Cabin, base above and top half below (ERA, 2024)

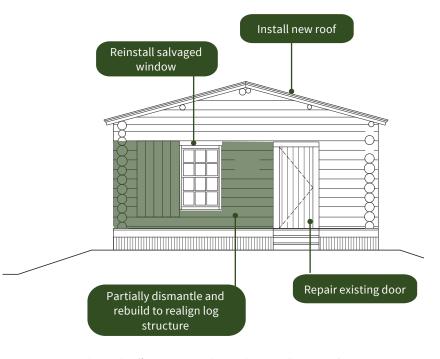
Telegraph Office - Proposed east elevation (ERA, 2024).

- Reapplication of chinking to the full exterior utilizing traditional materials and techniques to replicate the original appearance, texture, and colour.

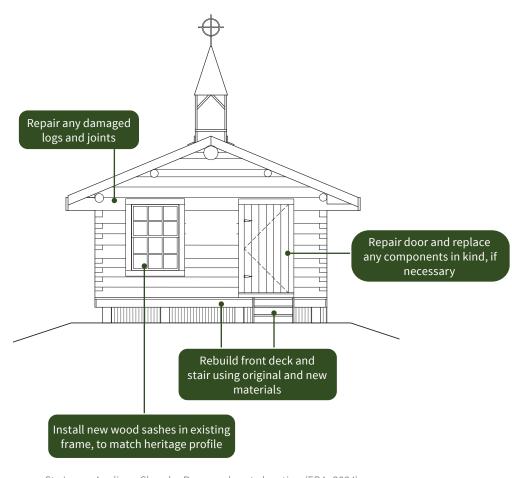
St. James Anglican Church - Proposed east elevation (ERA, 2024).

- Reapplication of chinking to the full exterior utilizing traditional materials and techniques to replicate the original appearance, texture, and colour.

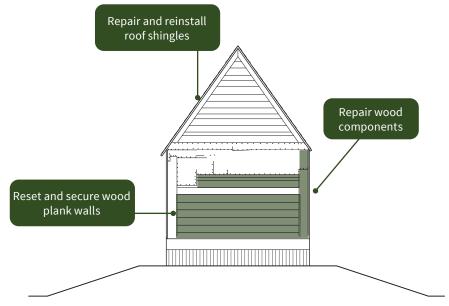
Metalworking Shop - Proposed west elevation (ERA, 2024).

- Installation of a new plank floor.

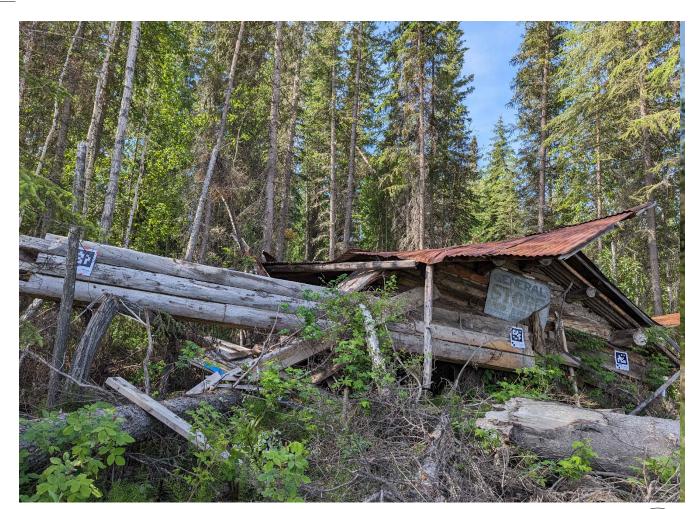
BUILDING REMNANTS / 9 CURRENT CONDITION (2024) \ AH101

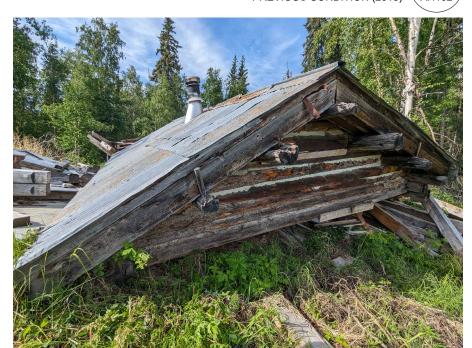
REMAINING ROOF STRUCTURE (EAST ELEV.) 8

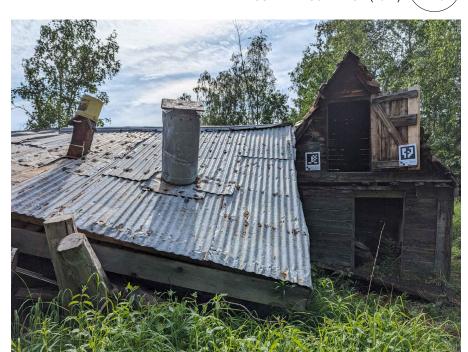
REMAINING ROOF STRUCTURE 7

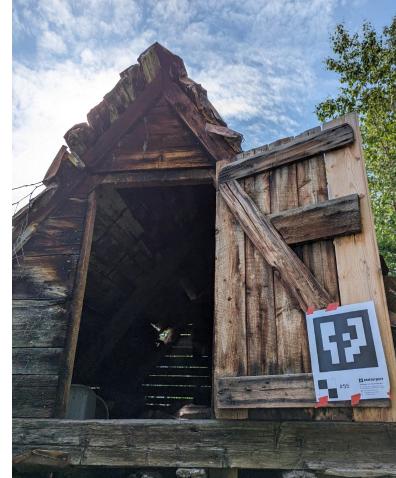
TYP. CONDITION ON EAST ELEV. / 10 CURRENT CONDITION (2024) \ AH107

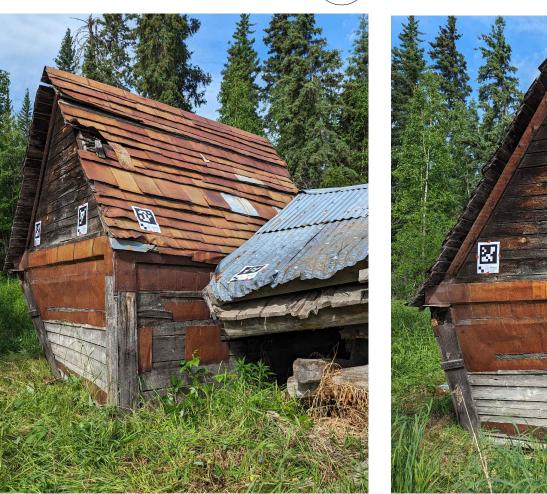
SOUTH ELEV. PARTIALLY OBSTRUCTED / 8 CURRENT CONDITION (2024) AH107
