Historic Sites Unit Department of Tourism & Culture 204 Lambert St Whitehorse, Yukon

ERA Architects Inc. #600-625 Church Street Toronto, Ontario M4Y 2G1 416-963-4497 Project # 24-052-01

4 INVENTORY AND CONDITION ASSESSMENT (JUNE 2024)

On June 12-13, 2024, ERA conducted a site visit to document and assess the damage and change that has occurred on Site as a result of the ice jam and flood, as well as during the 13 months following the event.

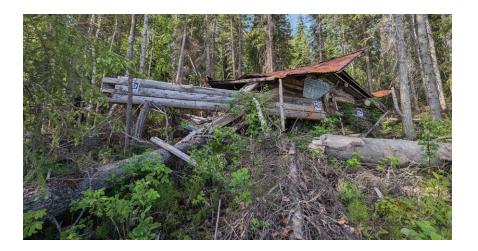
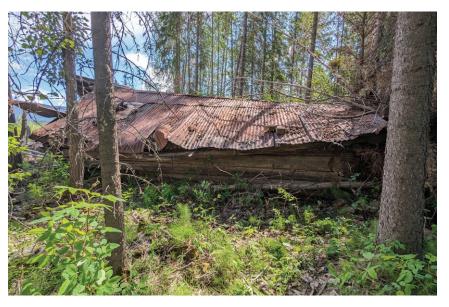
AFTER: Swanson's Store (ERA, 2024)

In the May 2023 ice jam and flood, the building was carried and collapsed at the western treeline, and substantially dismantled. While thick foliage around the building limited the condition assessment and documentation, the building was found to be in **defective** condition, with the majority of the structure missing, from grade level to the base of the roof.

• The lower two-thirds of the timber walls were collapsed; several long timbers were found displaced adjacent to the front of the 'building';

- Several elements could not be located including doors and windows;
- The existing floor structure was not observed;
- On the north side, the roofing system appeared partially intact with the corrugated metal in place, and some damage. On the south side, the roofing system was displaced with the sod roof partially exposed;
- Remnant debris from the building and flood aftermath was observed within and around the building.

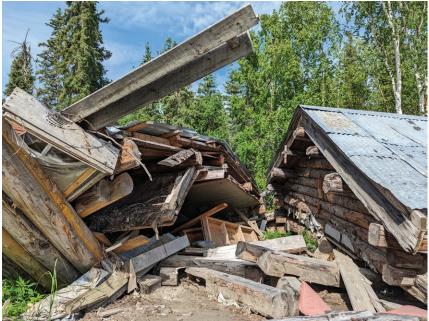
In the May 2023 ice jam and flood, the building was relocated, collapsed and resting on the Metalworking Shop, and substantially dismantled. The building was found to be in **defective** condition, with the majority of the

AFTER: Roadhouse from side, showing rear of main building and separation and breakup of former addition (ERA, 2024)

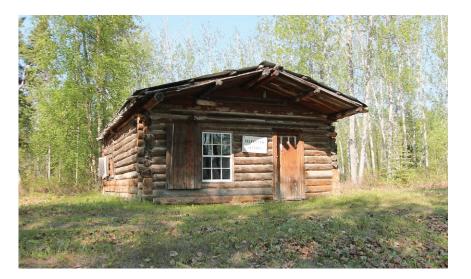
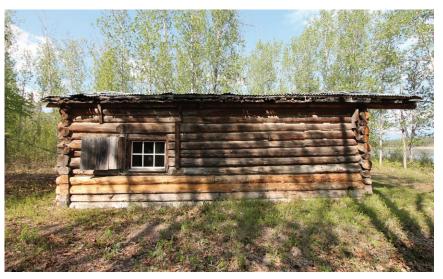
The Telegraph Station experienced minor relocation during the May 2023 ice jam and flood, but remains substantially intact as of June 2024. The building was found to be in **fair** condition, with select areas of **poor** condition.

- The timber walls appeared to be in fair condition with minor displacement of the logs at the front elevation;
- The floor structure appeared to be intact, and coated with silt and debris from the flood;

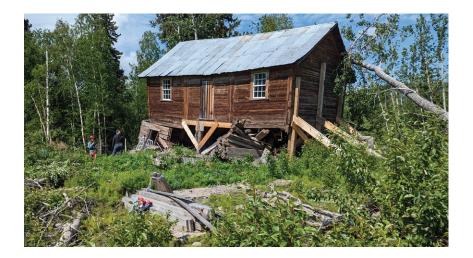
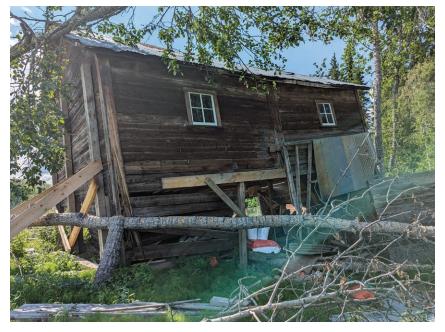
AFTER: North West Mounted Police Post (ERA, 2024)

- The building's foundation pads appeared to remain in the ground at the building's original location.

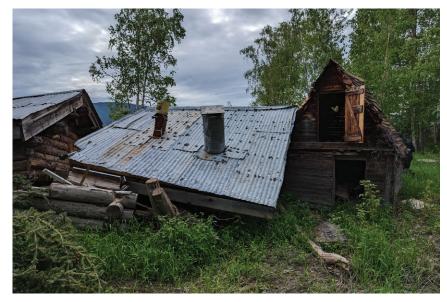
AFTER: Metalworking Shop (ERA, 2024)

The Metalworking Shop sustained damage in the May 2023 ice jam and flood, in part related to the collision of the Roadhouse building into its north elevation. The building was found to be in **poor** condition.

- The wood plank walls appeared to be in poor condition, with a hole observed at one corner with damaged planks;
- The ground floor was not visible due to items stored within the building and debris, but the second floor appeared to be in fair condition;
- The roof was damaged on one side due to the collision of the Roadhouse.

The metal roof cladding was bent in select locations. The ends of the plank roof sheathing were damaged, and in many instances broken off. A hole in the metal cladding was observed;

- On the roof's other side, several shingles were bent and deformed, and some had been dislodged;
- The building is leaning to one side due to the collision of the Roadhouse.

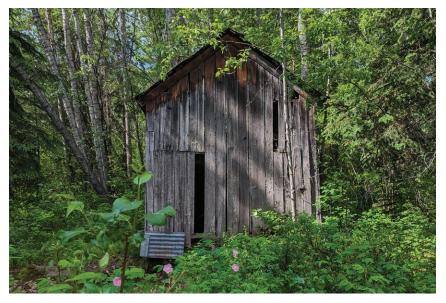
AFTER: Two-Storey Cache (ERA, 2024)

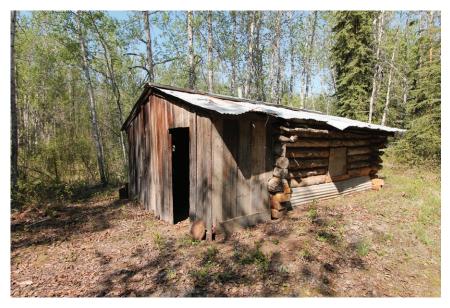
BEFORE: Willie DeWolfe Cabin (ERA, 2015)

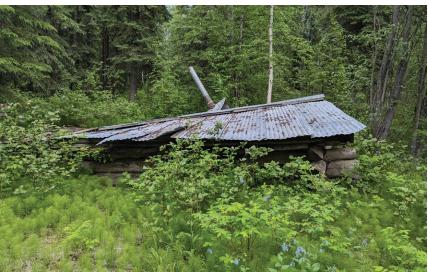
The building sustained substantial damage in the May 2023 ice jam/flood, when its upper half and roof were lifted and deposited next to the building, and the enclosed porch addition was collapsed and not observed. The building was found to be in **defective** condition. The condition review was cut short due to inclement weather.

- The floor of the cabin was partially intact, however several floor boards appeared to be missing; debris and silt from the flood was observed;
- The roof system, along with several layers of timbers, appeared attached, with visible damage to the corrugated metal roofing; the chimney stack had also lifted the metal roofing during its relocation;
- The main door remained on its hinges, with some minor damage to the wood on the door;
- The front framed entry (enclosed porch) was removed in the flooding; evidence of this structure was not observed;
- The stove and other interior artifacts remained within the cabin.

AFTER: Willie DeWolfe Cabin, base above and top half below (ERA, 2024)
